SB2/2021

Fatal crushing injury of a crewman on the upper vehicle deck of the roll-on roll-off ferry *Clipper Pennant* in Liverpool, England on 20 July 2021

MAIB SAFETY BULLETIN 2/2021

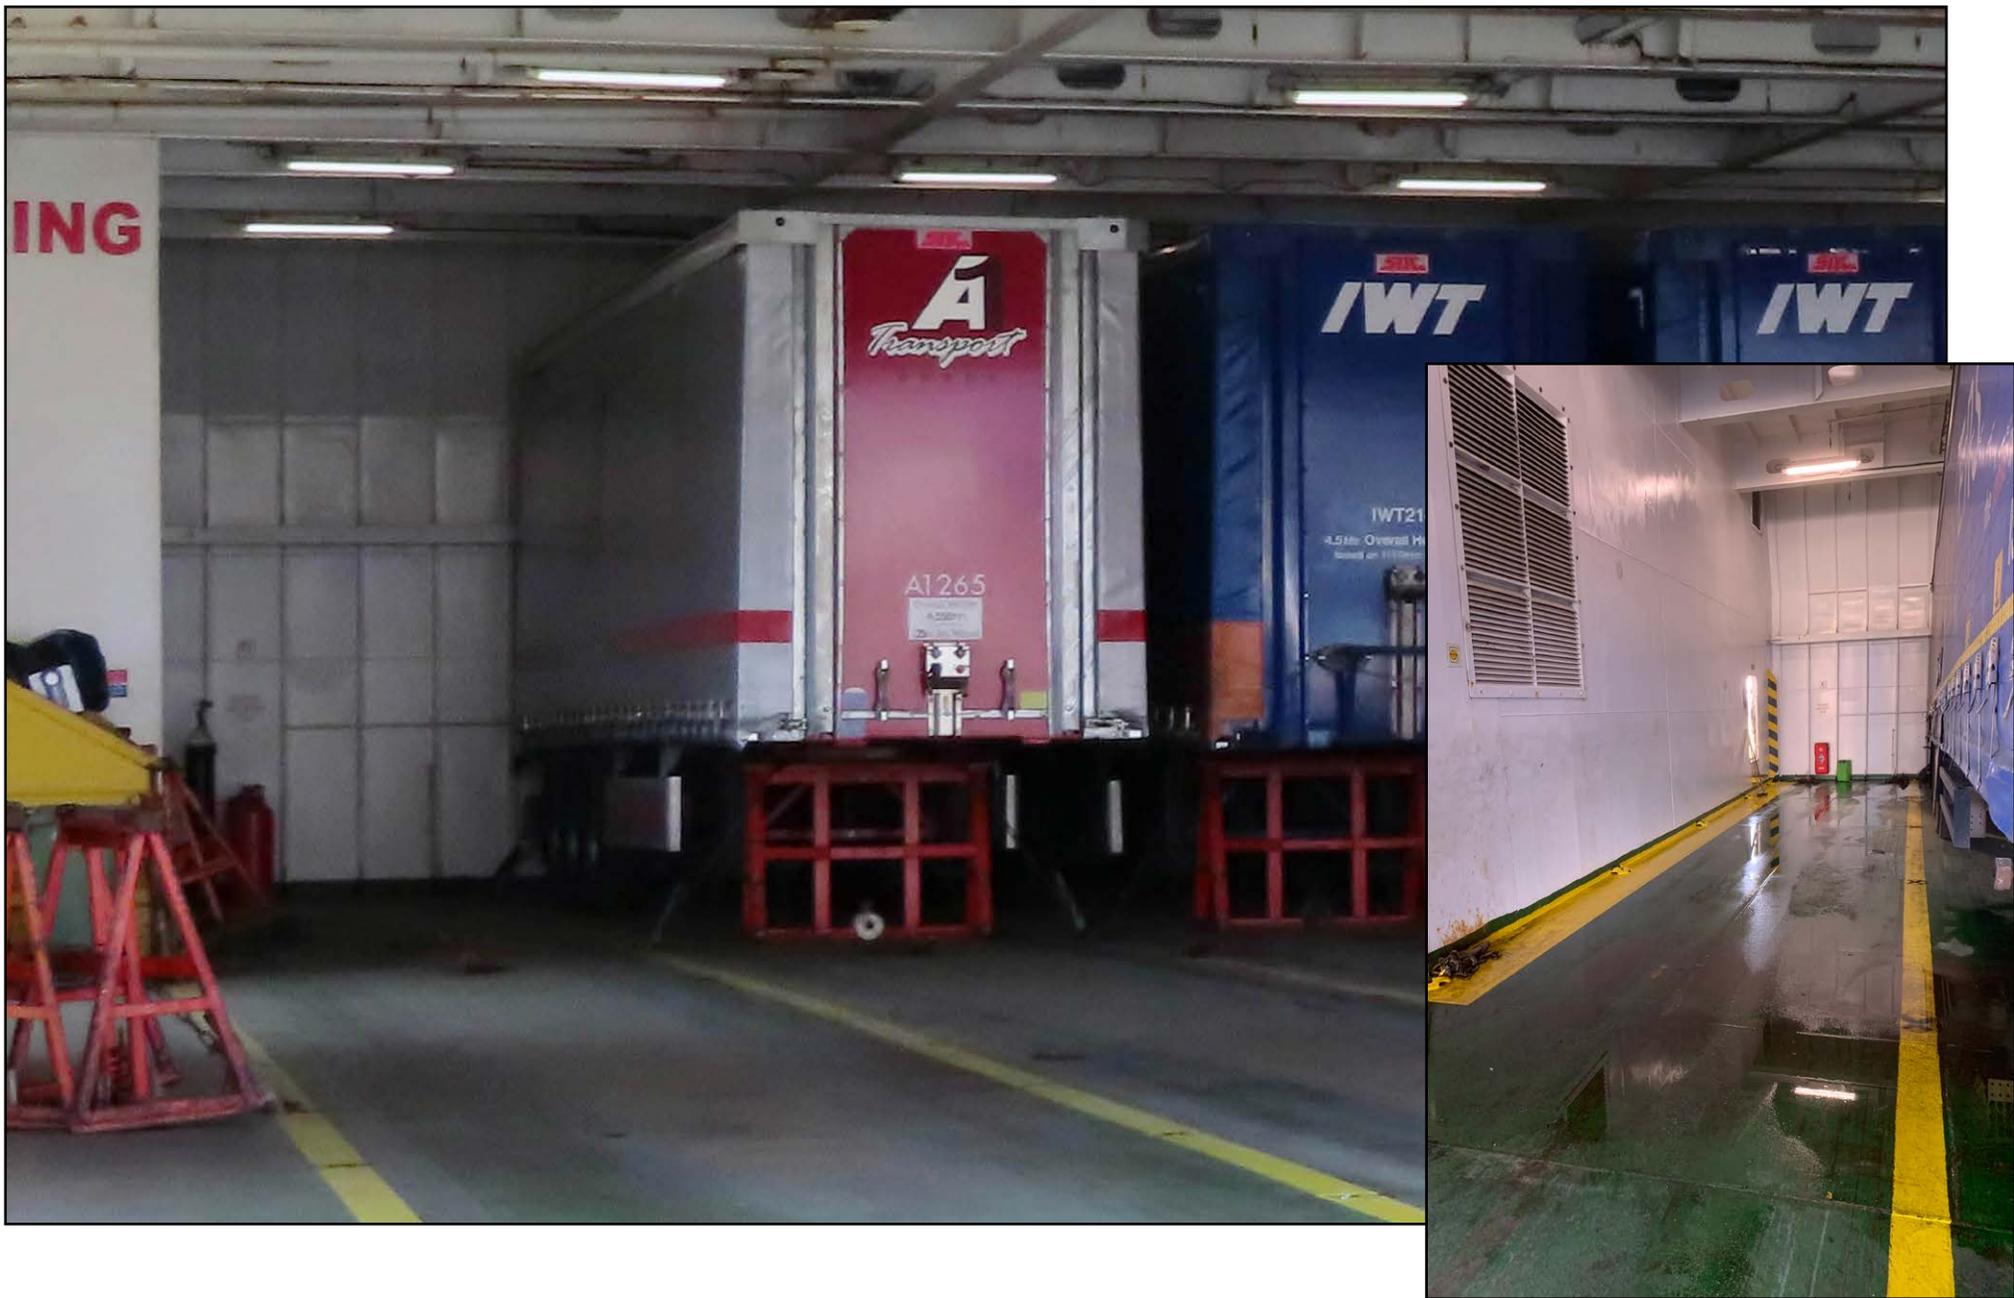
The accident occurred after the bosun had directed a tractor unit driver to push a semi-trailer into its stowage location, between a semi-trailer that had already been lashed and the bulkhead at the port forward end of the upper vehicle deck (**Figures 1 and 2**). As the semi-trailer was being manoeuvred, the bosun had positioned himself between the moving semi-trailer and the vessel's structure, resulting in the crushing accident.

All aspects of this accident are under investigation by the MAIB and a full report explaining the causes and circumstances will be published in due course. Nevertheless, it is apparent from the initial evidence collected that there is an extreme risk of crushing injuries in stowage spaces adjacent to the vessel's structure, with limited areas to remain clear or escape.

Figure 1: Reconstruction of the semi-trailer parking arrangement, with inset view of the space (post-accident)

Use of the port forward cargo stowage spaces has been temporarily suspended by the vessel's operator, pending further investigation and assessment.

- Review their cargo handling procedures to identify the hazards associated with stowage spaces where there may be limited areas for escape.
- Conduct a specific risk assessment for all such spaces. These spaces should then be marked and, unless appropriate mitigating measures can be put in place, not used.
- Ensure that onboard safety procedures and crew safety briefings reflect the guidance in COSWP Section 27.6.3.

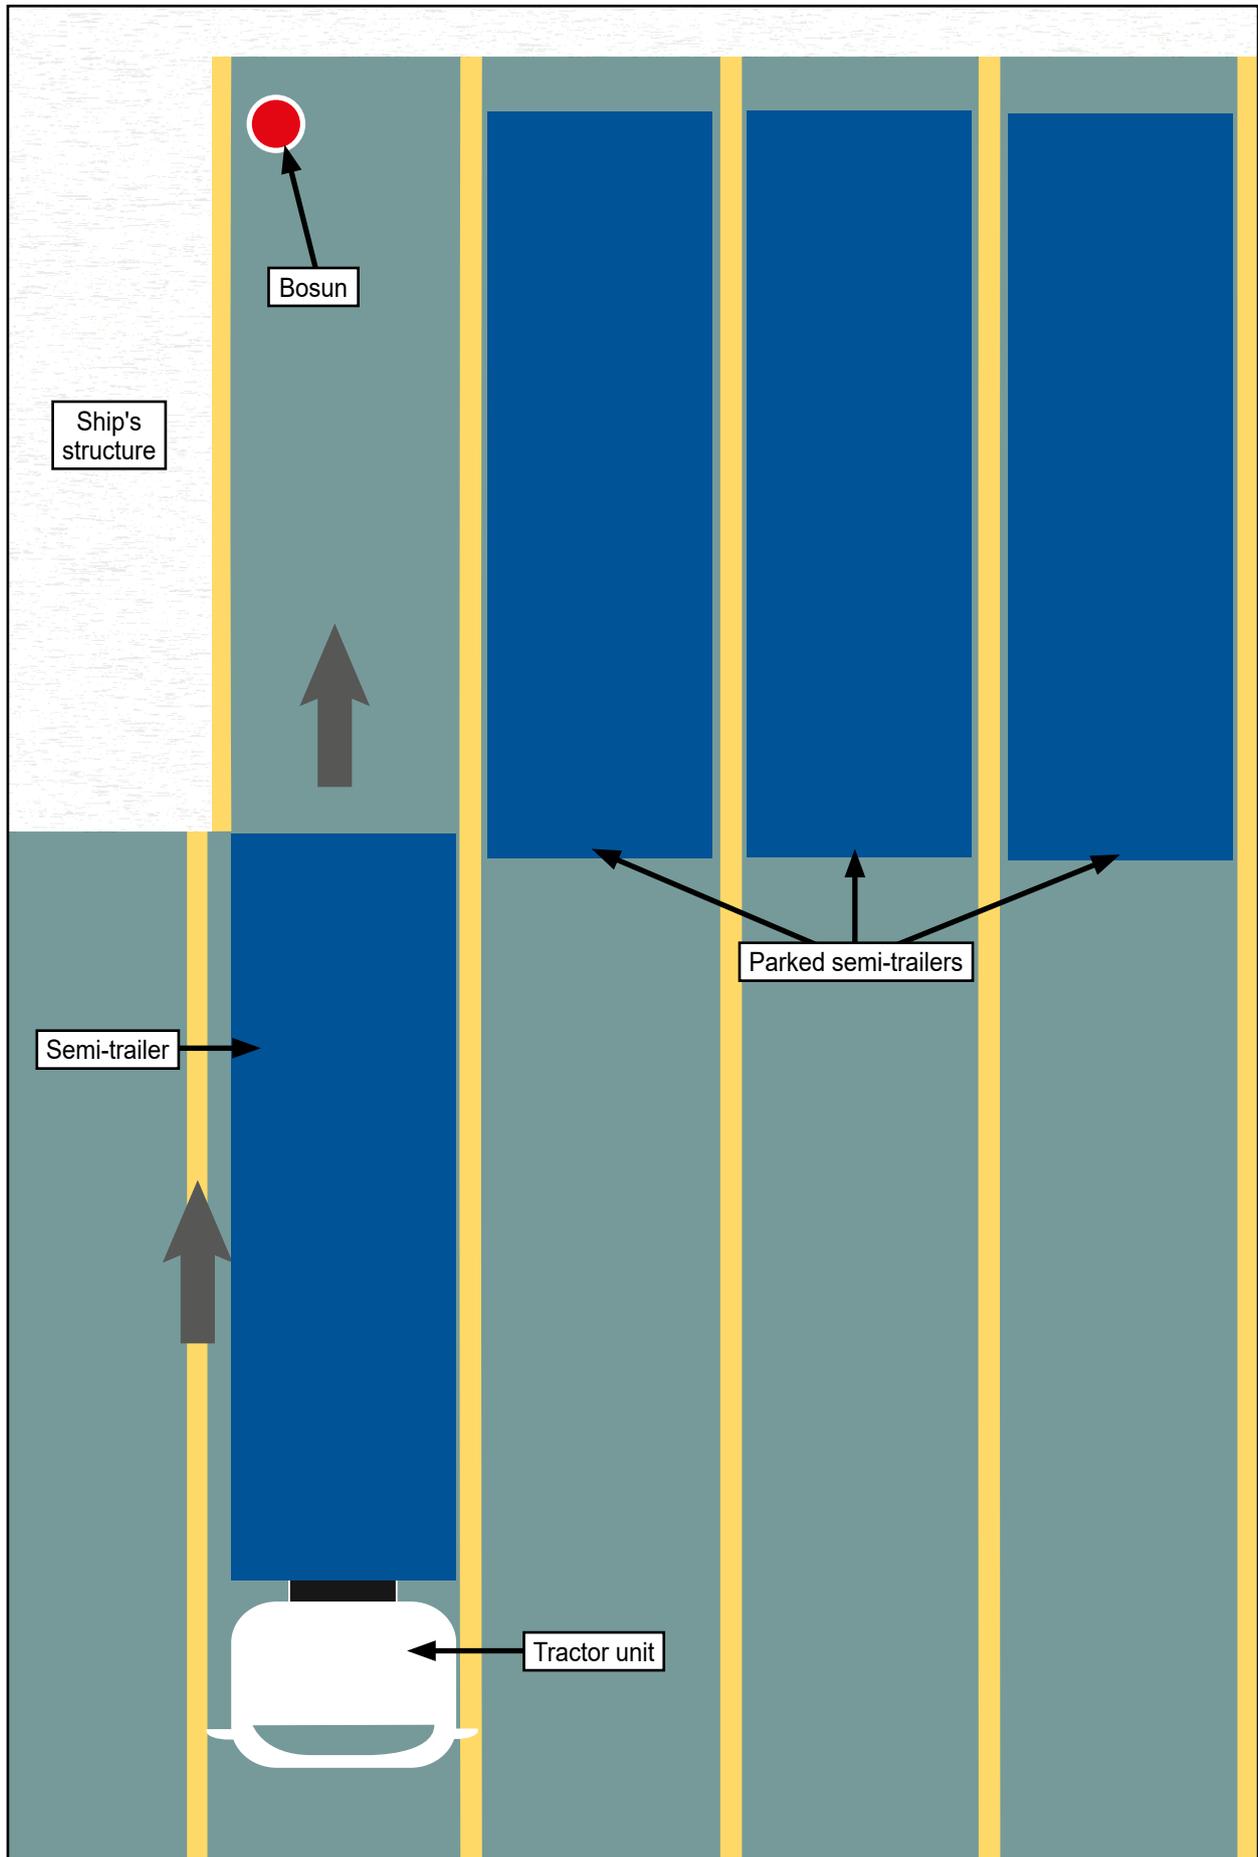
Figure 2: Graphic showing plan view of the semi-trailer's approach to the parking space
