FIRES ON RO-RO DECKS

There have been several serious fires in Ro-Ro spaces recent years and how to address this has been discussed in length. We issued a paper in 2005 (paper 2005-P018 identifying 25 fires within Ro-Ro spaces) and due to the ongoing debate we found it useful to revisit the paper and study recent fires (2005 - 2016) as well as considering impact of new rules and "new" cargoes represented by alternative-fuel vehicles.

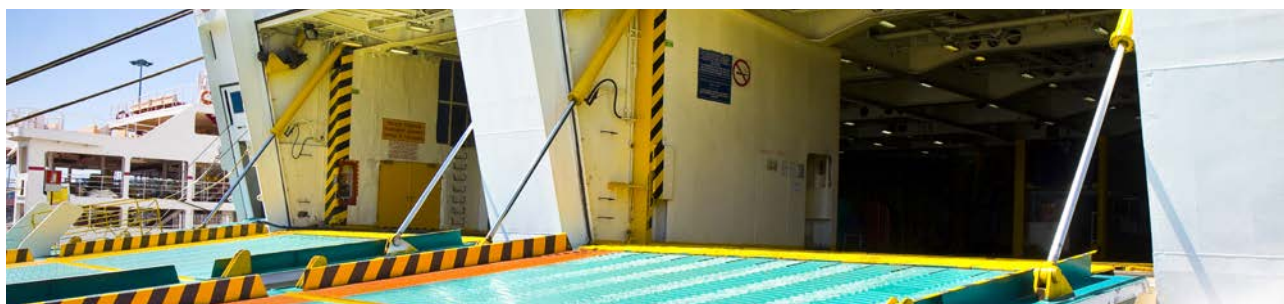
Eighteen fires on Ro-Ro decks were identified between 2005 and 2016; a summary can be found in Annex 1.

Assuming a fleet of 750 RoPax above 4.000grt, this represents 2.0×10^{-3} fires per ship-year. Five of these fires caused major damages, abandonment of the vessel and even injuries or fatalities, amounting to 0.56×10^{-3} cases per ship-year. This is a rather high number, and is therefore a risk that should be looked into.

- f. The use of the fixed fire-extinguishing system played an important role in fires causing major damages. In two cases, the water was not discharged onto the deck on fire (Norman Atlantic and Lisco Gloria); in another, the release was delayed for 25 minutes (Commodore). Data for the Sorrento and Sunflower Daisetsu is not yet available.

- g. The "successful" cases are due to rapid response (applying the deluge system quickly or fast approach by the fire team, sometimes combined with discharge of cargo when entering the port).

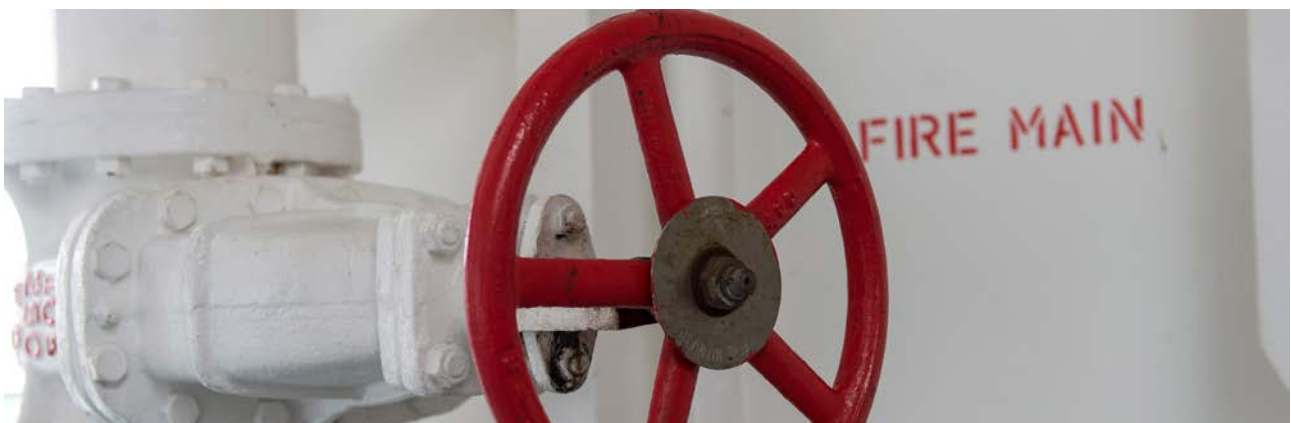
Nine fires on Ro-Ro decks were identified between 2005 and 2016; a summary can be found in Annex 3.

- One fire reignited two days later when cargo was opened in a controlled way (the new fire was therefore quickly brought under control).
- In several cases, the damages to structure were not severe - maybe due to the restricted ventilation conditions (these vessels typically have closed cargo holds).

- The damage to the cargo (predominantly new cars) represents a significant cost in some of the cases.
